**Reducing the impact on sand mining of  
Kosrae and the provision of a long-  
term supply of sand aggregate for  
construction: A proposed way forward.**

**Draft for consultation**

**Development Review Commission  
January 2000  
Updated 2002 to include 2000 census data**

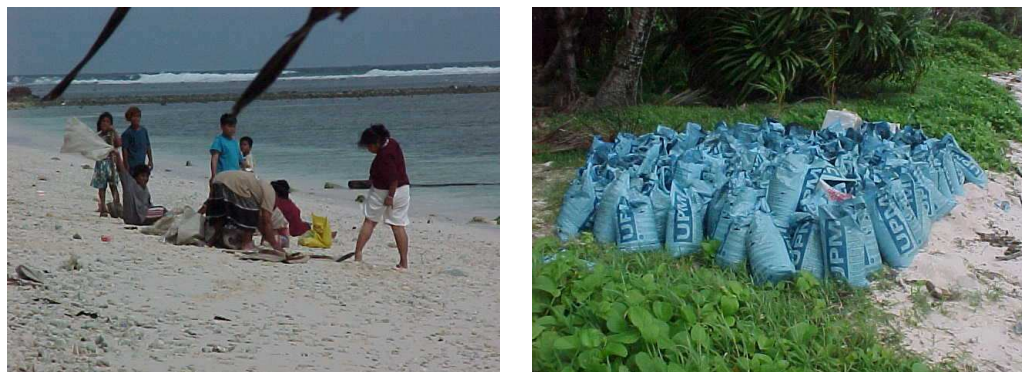
**Figure 1:** Typical sand mining practices on Kosrae

Most sand and coral rubble removal from the beach is due to local people, primarily within the subsistence economy, removing the material for house construction, landscaping or landfill. This is generally conducted by hand, often just a few bags at a time (when a bag of cement can be bought). However, with a rapidly increasing population, increasing development, and the current extent of erosion on Kosrae's coastline, these sand mining practices are still significantly exacerbating coastal erosion.

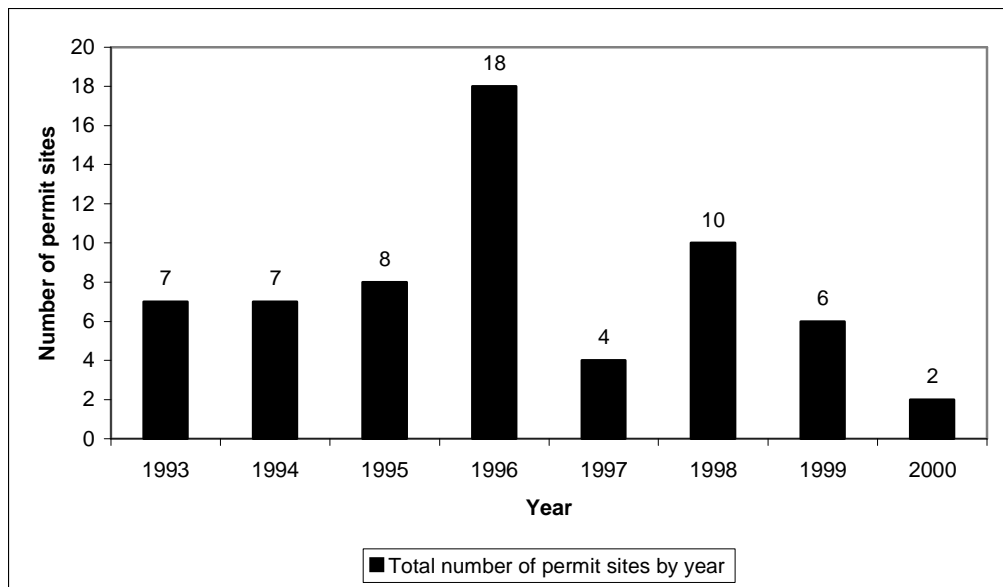
**Figure 7:** Total number of permitted sand mining sites by year (1993 – January 2000).

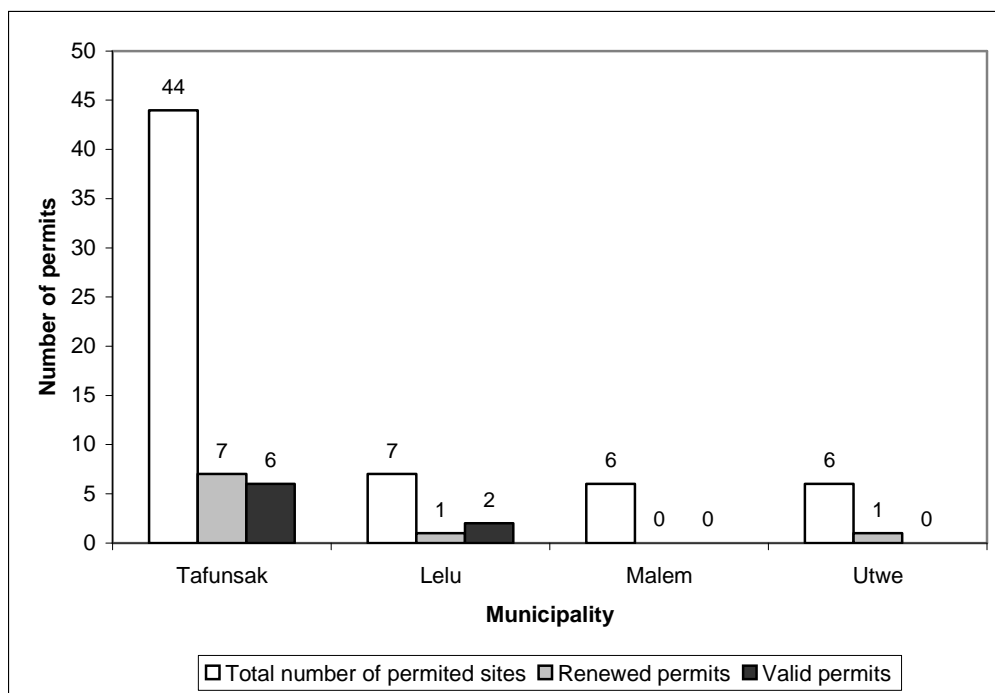
**Figure 8:** Permitted sand mining sites in each Municipality (1993 – January 2000).

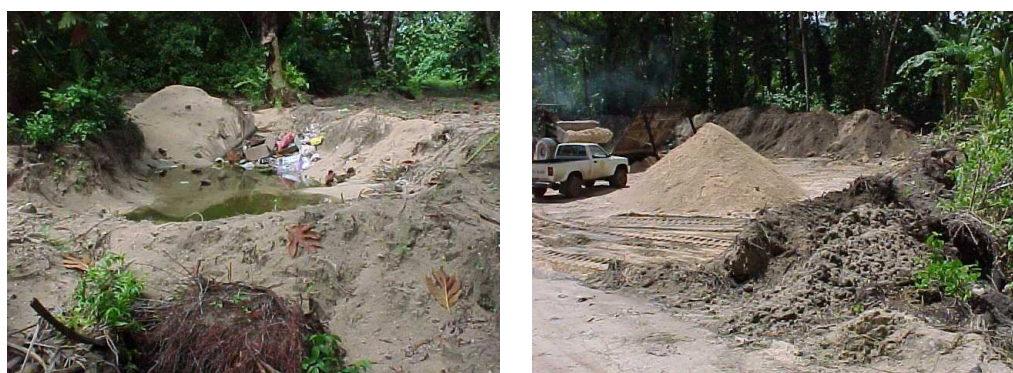
**Figure 9:** Typical small scale permitted sand mining site (left) and larger scale government site supplying sand for the hard sealing of the road between Okat and Walung.

It is difficult to obtain an accurate assessment of the volume of sand extracted from permitted sites. Most permits rarely specify the actual dimensions or volumes to be extracted and in many cases actual excavation rarely relates to the permit details. Assessing actual excavated volumes has proved to be difficult without detailed surveying and due to many of the pits being backfilled (a condition of their permit).

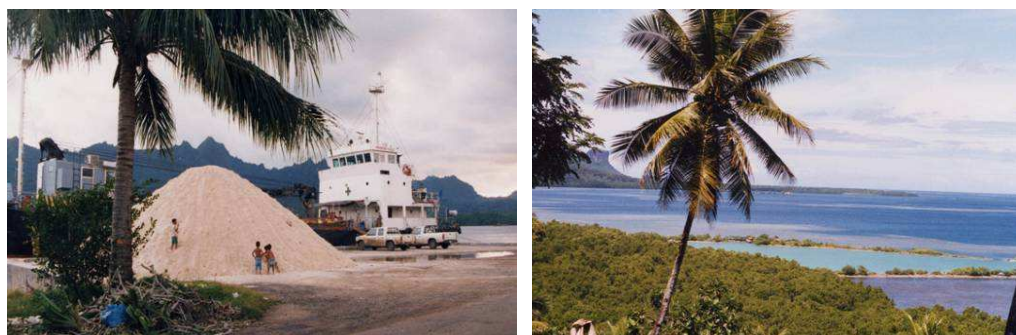
**Figure 10:** Imported sand from Pohnpei at Lelu (right), and an old reef dredge pit on Pohnpei (left).

Sand imported from Pohnpei is a relatively recent occurrence, starting in the later part of 1999. The sand is sourced from reef flat dredging operations on Pohnpei's reef flat. However, the Pohnpei EPA are keen to see the export of sand to Kosrae from this source stopped and such dredging practices limited and

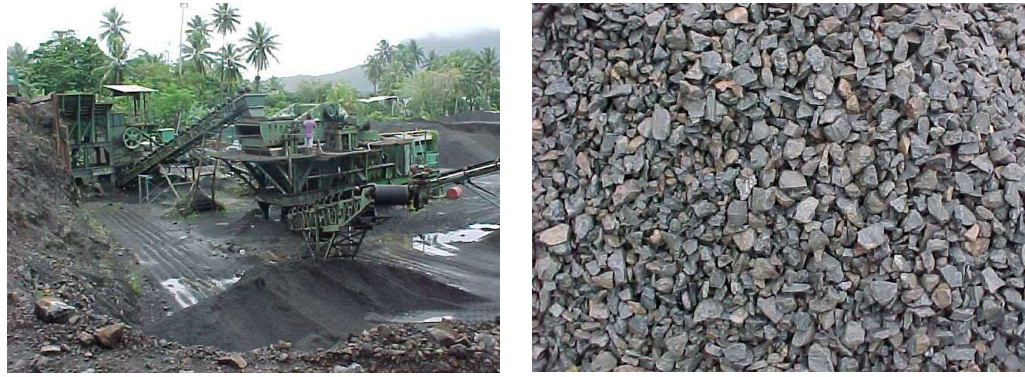
**Figure 12:** The crushing plant and quarry at Sansrick, and the 1/2” chips produced.

Crushed volcanic rock is used on Kosrae to produce 3/8" 1/2" and 3/4" chips for concrete and other construction, Figure 12. Black Micro have a crushing plant located at Inlas quarry in Sansrick. Rock is blasted or dug from the quarry face and crushed into the three aggregate sizes.

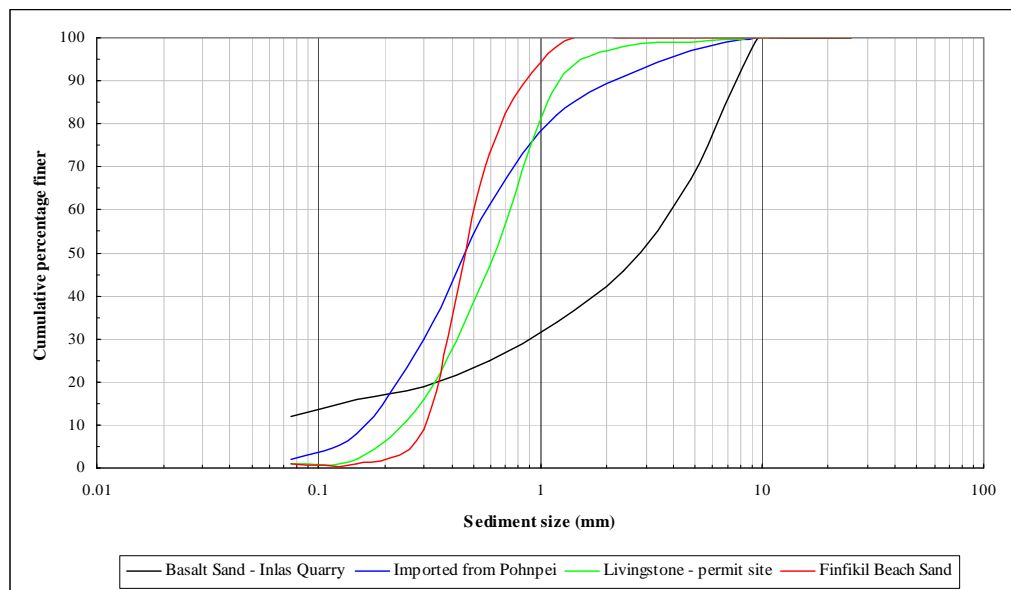
**Figure 13:** Typical sand gradings from various sources on Kosrae.

A waste material is produced from the existing crushing operation (black sand). Some concrete tests have been conducted by Public Works, which have found that the mix does not bind well. This is primarily due to the high percentage of aggregate above 2.38mm (8 mesh) and below 0.074mm (200 mesh), Figure 13. To use this material as a sand aggregate source would require screening to remove the fine and course particle with such equipment not available on Kosrae at present. However, virtually all of the stockpile that has accumulated is now being used as part of the sub-base for the road upgrading project between Okat and Tofol. Furthermore the quantity of waste material produced is insufficient to meet Kosrae’s long term demands.

Sand from Pohnpei is currently being imported to Kosrae by Kosrae White Sands. This sand is dredged from the reef on Pohnpei and there is considerable pressure by the Pohnpei EPA to reduce this practice. A number of geological studies have recently been conducted on Pohnpei (Smith et al, 1998, Marahaj, 1999) which have recommended that reef flat dredging be reduced and that the emphasis be placed on crushed volcanic aggregates for construction material. A typical sediment grading curve for sand aggregate imported from Pohnpei is shown in Figure 13.
